**Flood Control Project Maintenance
Levee Inspections**

Fall 2013 Levee Maintenance Deficiency Summary Report

Sacramento River Basin

Sacramento Maintenance Yard Sacramento Bypass

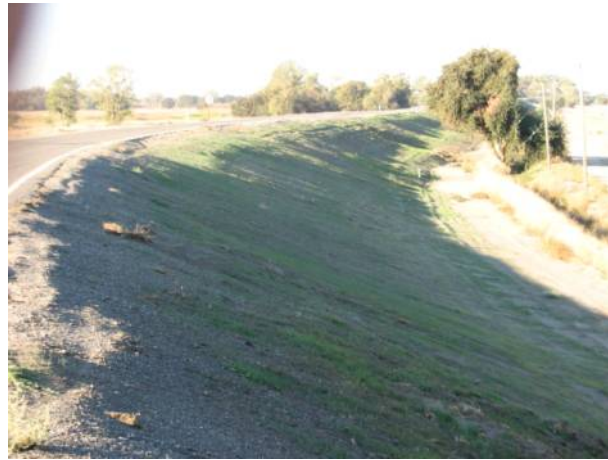
Levee Mile Report Line	4
Start Levee Mile	0.04
End Levee Mile	1.73
Location	Land Side
Category	Earthen Levee
Item	Vegetation

The levee has been burned and the new vegetation is starting to grow. Fall 2013

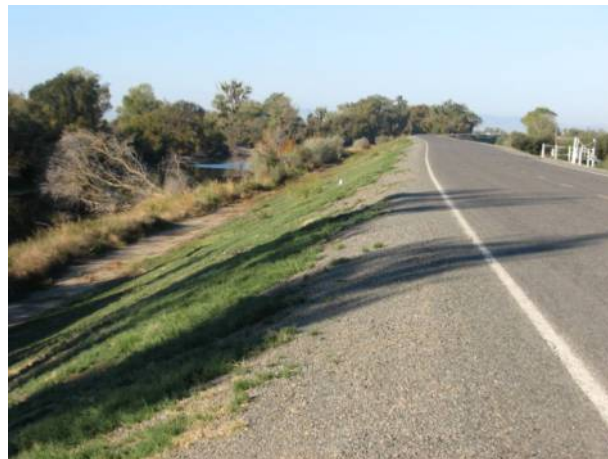
Levee Mile Report Line	5
Start Levee Mile	0.44
End Levee Mile	1.73
Location	Water Side
Category	Earthen Levee
Item	Vegetation

The levee has been burned and the new vegetation has begun to grow. Fall 2013

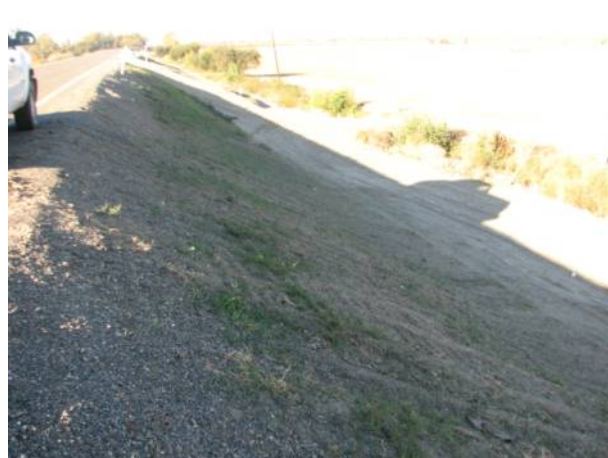
Levee Mile Report Line	6
Start Levee Mile	0.46
End Levee Mile	0.46
Location	Land Side
Category	Earthen Levee
Item	Slope Stability

The area has been resloped and complies with standards. Fall 2013

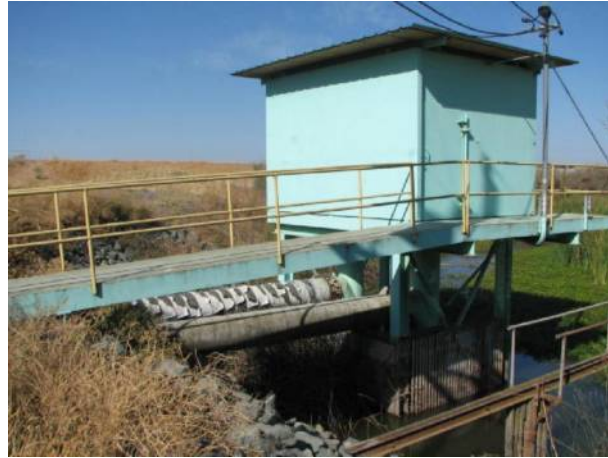
Levee Mile Report Line	8
Start Levee Mile	1.14
End Levee Mile	1.14
Location	Crown
Category	Supplemental
Item	DWR UCIP Field Study

Landside view: pumping plant overview

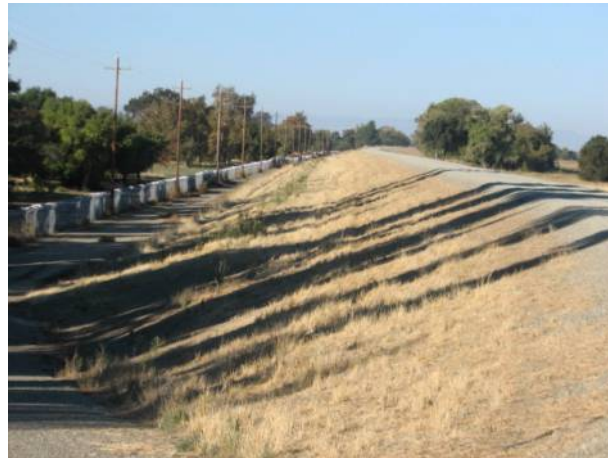
Levee Mile Report Line	1
Start Levee Mile	0.01
End Levee Mile	1.76
Location	Land Side
Category	Earthen Levee
Item	Vegetation

The levee has no unwanted vegetation. Fall 2013

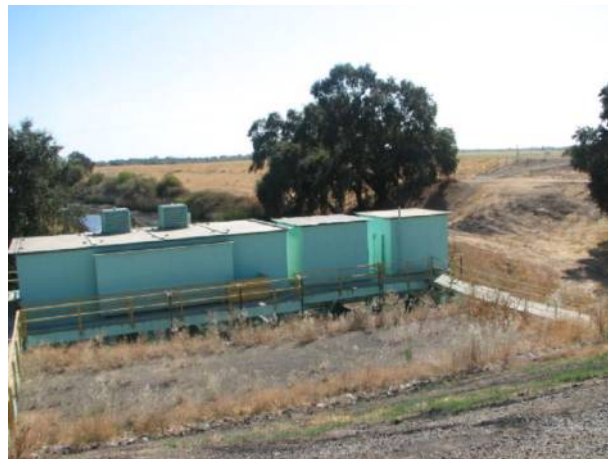
Levee Mile Report Line	2
Start Levee Mile	1.19
End Levee Mile	1.19
Location	Land Side
Category	Supplemental
Item	DWR UCIP Field Study

DWR ID: DWR_ST0008_02_f_0_1										
3	1.19	1.19	Supplemental	DWR UCIP Field Study	LS	M	Inspector Comments: FS_ID:6441 EP_NO: 11826 Repair Type: Non-Urgent Crossing Status: Found UCIP Comments: Vertical GI pipe trash rack in inlet structure; trash rack has fallen apart and found in the water. Big pumping plant with 5 pipes. FIELD_STRUCT_DESC: A 36-inch drainage pipe through the levee, 2.0 feet below the crown. A steel pipe pump structure and pump house on the landward side with a vertical pump. A siphon breaker located on the apex of the pipe near the LS of the levee. A flapgate installed on the discharge end of the pipe. (App. No. 11826 - R.D. 537) 10/76. FS Date: 10/4/2012	38.597544 ° -121.576621 °	38.597544 ° -121.576621 °	2
DWR ID: DWR_ST0008_02_f_0_2										
4	1.76	1.76	Earthen Levee	Encroachments	LS	M	PR : Prunings	38.594777 ° -121.586525 °	38.594777 ° -121.586525 °	5 Y
DWR ID: DWR_ST0008_02_f_2013_5

Landside view: overview of the pumping plant

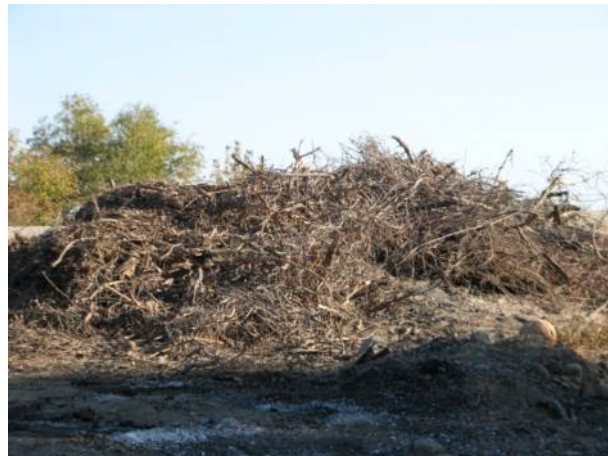
Levee Mile Report Line	4
Start Levee Mile	1.76
End Levee Mile	1.76
Location	Land Side
Category	Earthen Levee
Item	Encroachments

The never ending pruning pile at the end of the unit. Fall 2013
